INITIAL GEOHAZARDS EVALUATION AND GEOLOGICAL STUDY: BEARTOOTH HIGHWAY, U.S. 212, WYOMING

Prepared for
Department of Transportation
Federal Highway Administration
Central Federal Lands Highway Division
Lakewood, Colorado

October 27, 1998

WCFS Project No. FHAT0011

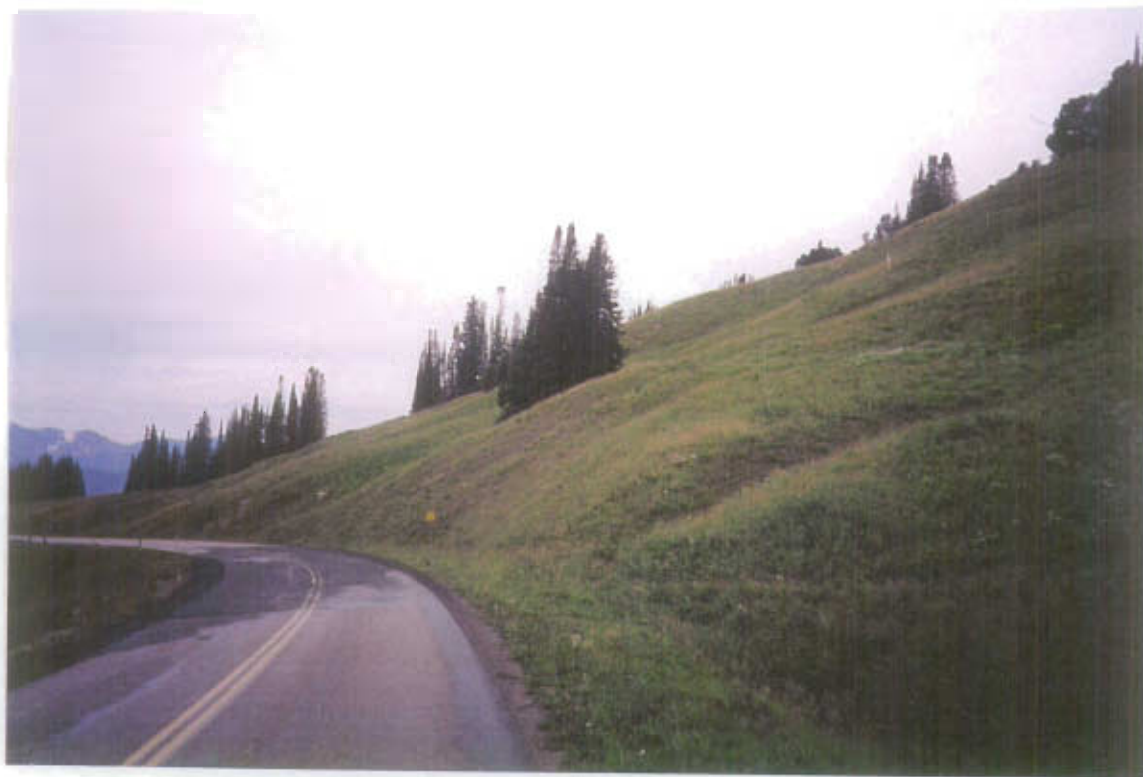
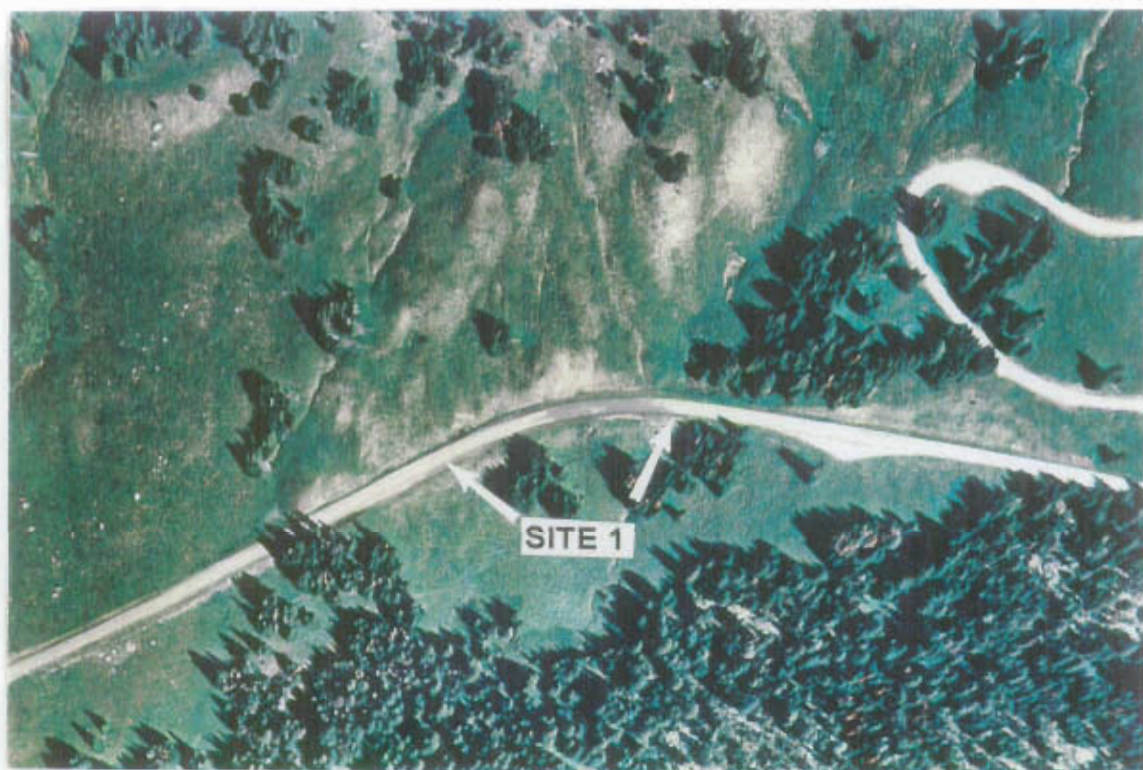
Figure
2

The existing alignment crosses a slope of approximately 1:4 (vertical:horizontal) in this area. The slope is hummocky and apparently unstable, the road has notable dips in grade, and pavement has been repaired (Figure 2). Silty and clayey colluvial soil imply that bedrock is a silty shale.

Surface drainage from the slope above the road is collected in an unlined toe ditch which drains easterly to a cross culvert. Thick, green grasses and plants downslope of the road suggest drainage is poor.

Potential geologic hazards include excessive settlement and landsliding. The indications are that the foundation conditions in this area include wet clayey silt and weathered shale bedrock, which will be relatively weak and compressible. Furthermore, there is apparently an existing shear surface beneath the roadway. Placement of fill could reactivate or accelerate movement on this surface.

Investigation in this area should include test holes to evaluate the existing roadway foundation and the foundation of proposed fill outboard of the existing roadway (see recommendations below).

At a minimum, two standpipe piezometers and one slope inclinometer should be installed to monitor water level and potential slope movement. Continuous soil core sampling may prove to be useful for identifying existing shear surfaces in soil and weathered bedrock. We recommend the driller be prepared for this type of drilling and sampling.

1. Avoid cutting the inboard slope. It is already oversteepened and probably has a low margin of stability.
2. Widen by placing fill on a prepared foundation. Use granular fill derived from excavation in the igneous rocks east of the site as much as possible. Subsurface drainage should be incorporated in the embankment if free draining materials are not used.
3. Provide improved surface drainage using toe ditch drains, possibly lined, and cross culverts.
4. Use results of investigation and instrumentation data to develop final design of embankment and drainage.

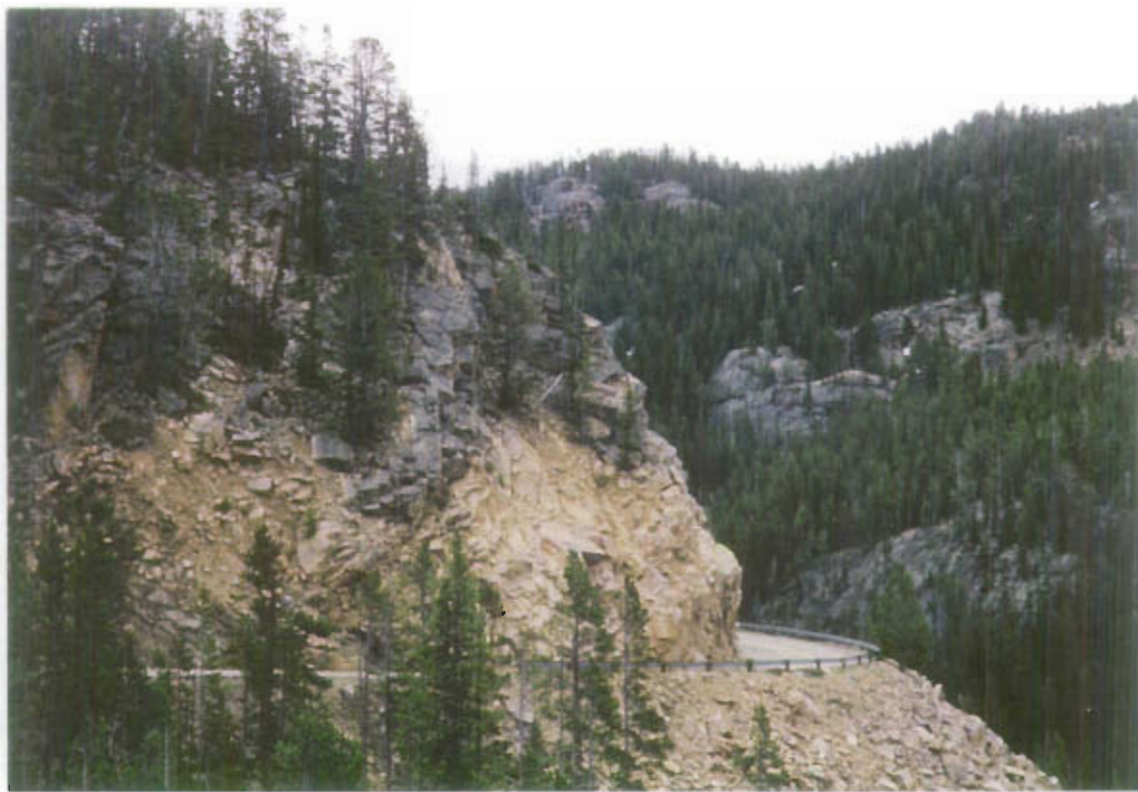
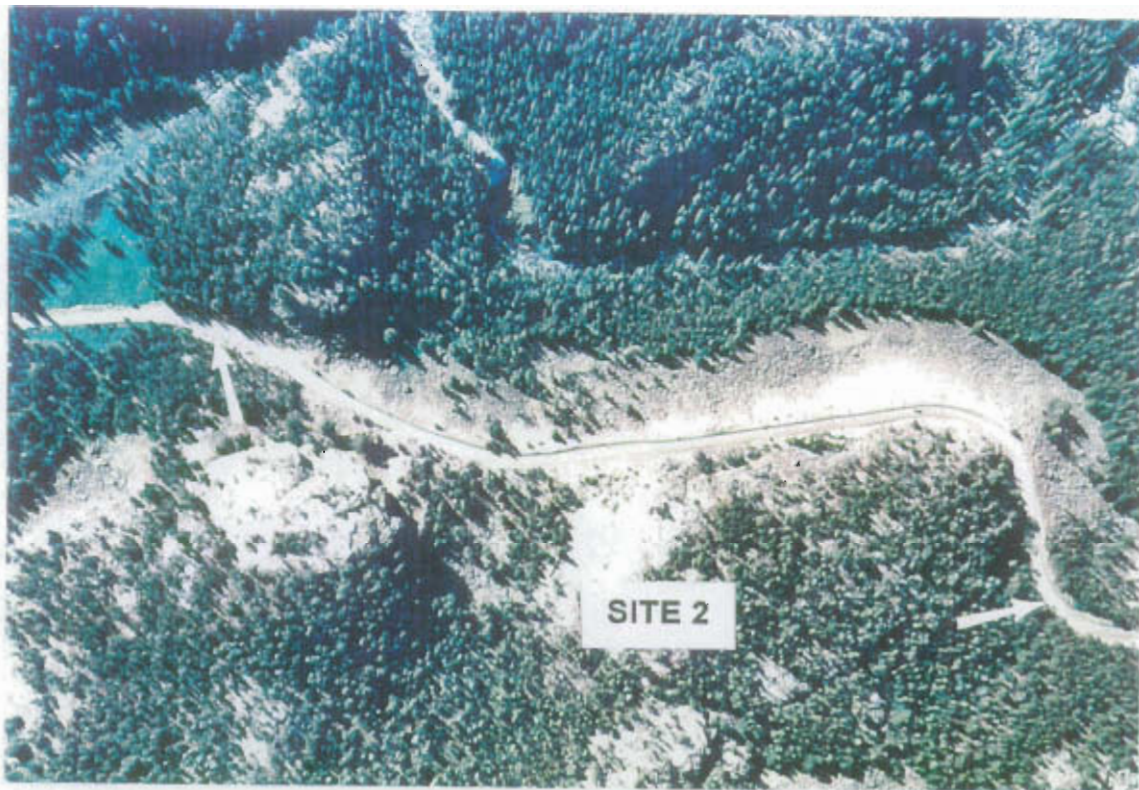
Figure
3

The road is on a cut and fill section through this area, as shown on Figure 3. The road travels around a sharp outside corner near Station 41+600 and is relatively straight from 41+700 to 42+000 (see Figure 1). Bedrock is granite gneiss. The rock slope between 41+600 and 41+700 is about 25 m high and the lower 15 m is cut slope. The cut slope presents a very high rockfall hazard. Large blocks have loosened and their release appears imminent. The rock quality appears to improve about 10 to 30 m in from the rock face on the corner, as indicated by greater joint spacing, less iron staining, and larger talus (on the slope below).

The rock slope between 41+700 and 42+000 is about 30 m to 50 m high. For most of this length there is an apron of more weathered rock and flatter slope angle near the toe of the slope. The existing rock cut is within this apron.

The potential geologic hazard at this site is rock slope stability and rockfall from the cut slope, as discussed above.

We recommend the investigation be designed to evaluate the joint patterns and rock quality of rock outcrop above the road and the bedrock profile beneath the road. Detailed geologic mapping of the rock outcrop should be conducted. Because the existing rock cut appears to have numerous blast-induced fractures, the size of the potential cut here is large, and there appears to be some improvement in rock quality behind the existing face, the program should include two or three core holes on the rock outcrop above the road. The investigation plan should be finalized after the site is surveyed and topographic mapping above and below the road has been generated.

Test holes should also be drilled along the centerline and outboard shoulder of the road between about 41+700 and 42+000 to evaluate foundation conditions for walls or half bridges. Seismic refraction surveys should be conducted to extrapolate information from the test holes. Seismic refraction is probably the best geophysical method for locating bedrock at this site.

This section of highway presents the most difficult conditions for widening. Our preliminary recommendation is for excavation between about 41+600 and 41+800. A blasting plan submittal should be required prior to construction and it should be reviewed by a qualified engineer or geologist. Rock bolts of about 4 to 6 m length will likely be required to support the excavation. Ground anchors may also be required. We do not recommend building retaining walls or bridges beneath such a hazardous slope.

Conditions for rock cut and for MSE wall construction improve between approximate stations 41+800 and 42+000. The existing rockfall hazard is less in this area. It appears that a partial width rock cut could be made within an apron of weathered rock without adversely affecting the

stability of the higher rock face. However, from a constructability standpoint, it may be desirable to remove the entire apron, or nothing at all. It also appears that an MSE wall or half bridge could be constructed on the outboard side of the road to accommodate the increased road width and a pullout for waterfall viewing. It may be practical to found the MSE wall on bedrock.

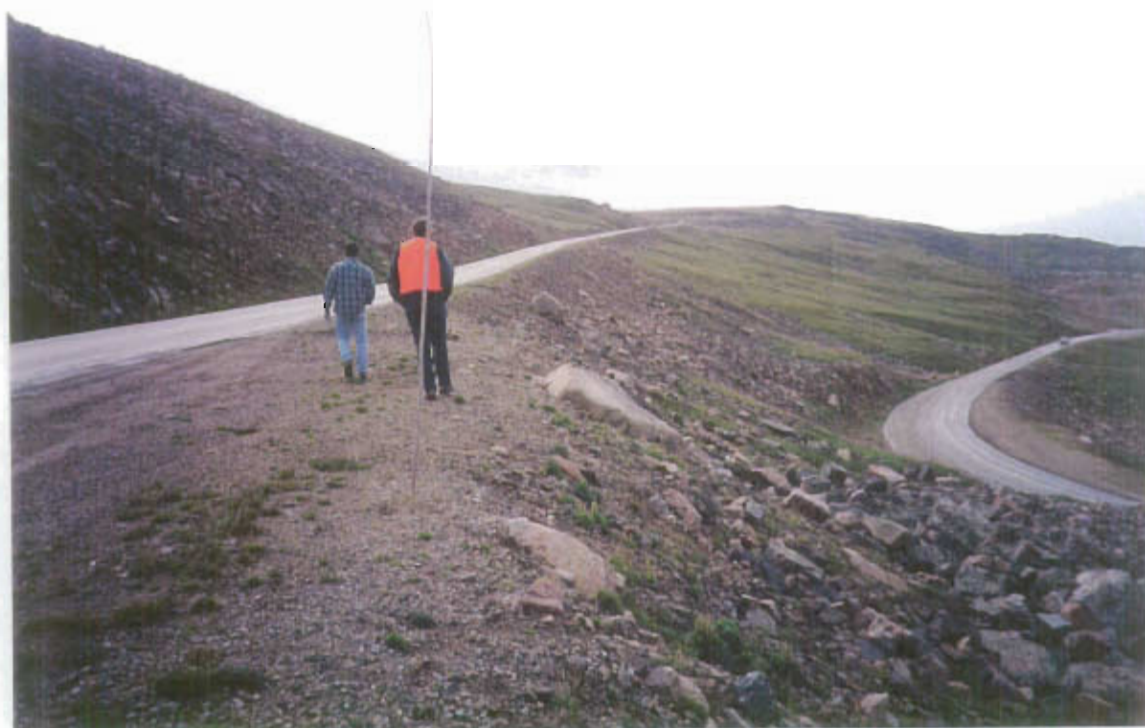
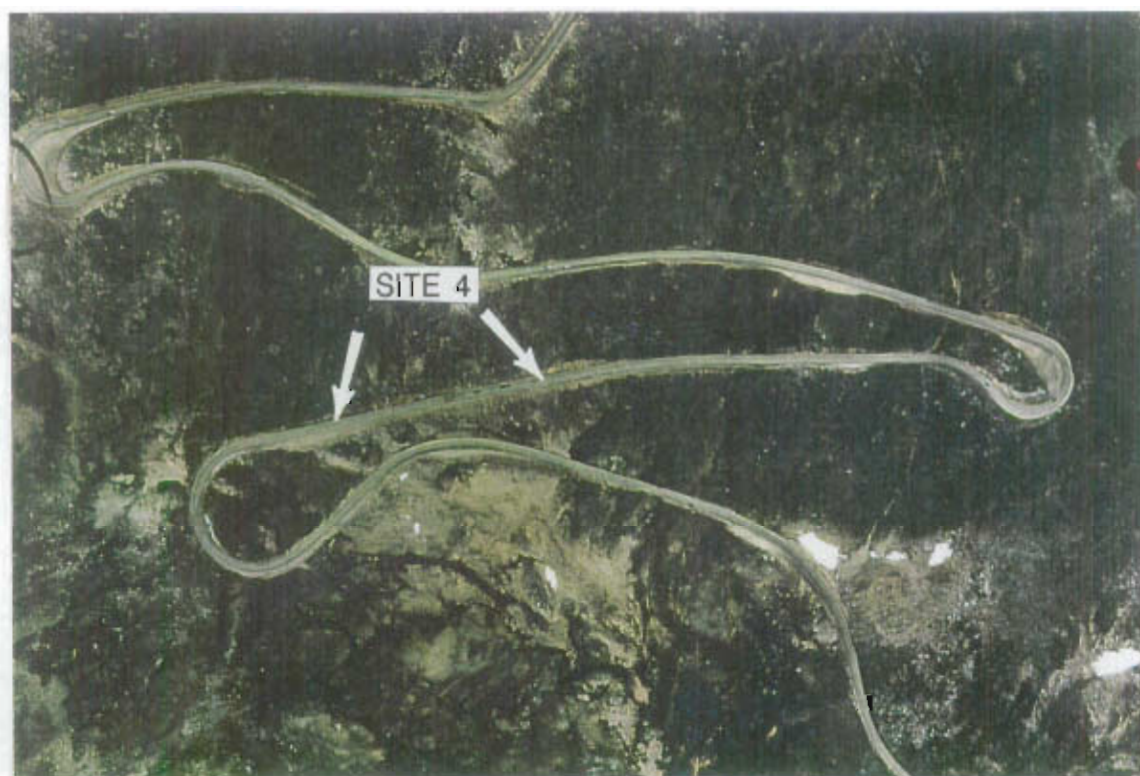
Figure
5

The road climbs above a broad plateau with three hairpin turns, Site 4 is located near the lowest turn where the upper and lower roads are closest together, as shown on Figure 5. These switchbacks are highly visible from below. This is also a heavy snowdrift area and guardrail is not desired.

The bedrock is highly fractured in this area. It appears to outcrop in a few places above and below the road, and is probably at shallow depth where it does not outcrop.

The potential geologic hazard at this site is slope instability. This potential is greatest above the road, and cutting is not recommended for this reason. There would be little risk of instability for a fill slope below the road, however the fill slope would probably not catch the existing ground before the shoulder of the lower road, and it would be highly visible.

Investigation at this site should include mapping of bedrock outcrop on the slope, test holes from centerline and the outboard shoulder, and a seismic refraction survey. The focus of the investigation should be on identifying the location of the bedrock contact and the excavatability of bedrock near the contact.

Our preliminary design recommendation is for an MSE retaining wall outboard of the current road shoulder. Although bedrock is shallow, it is probably weak enough and fractured enough to allow easy excavation and construction of the wall on a relatively uniform bedrock foundation. The toe of the wall would probably catch near the toe of the existing fill slope, so the wall would not impact the natural slope below the fill.

Excavation of the inboard slope is not recommended because of the poor rock quality. An engineered retaining wall would probably be required to support the cut slope.

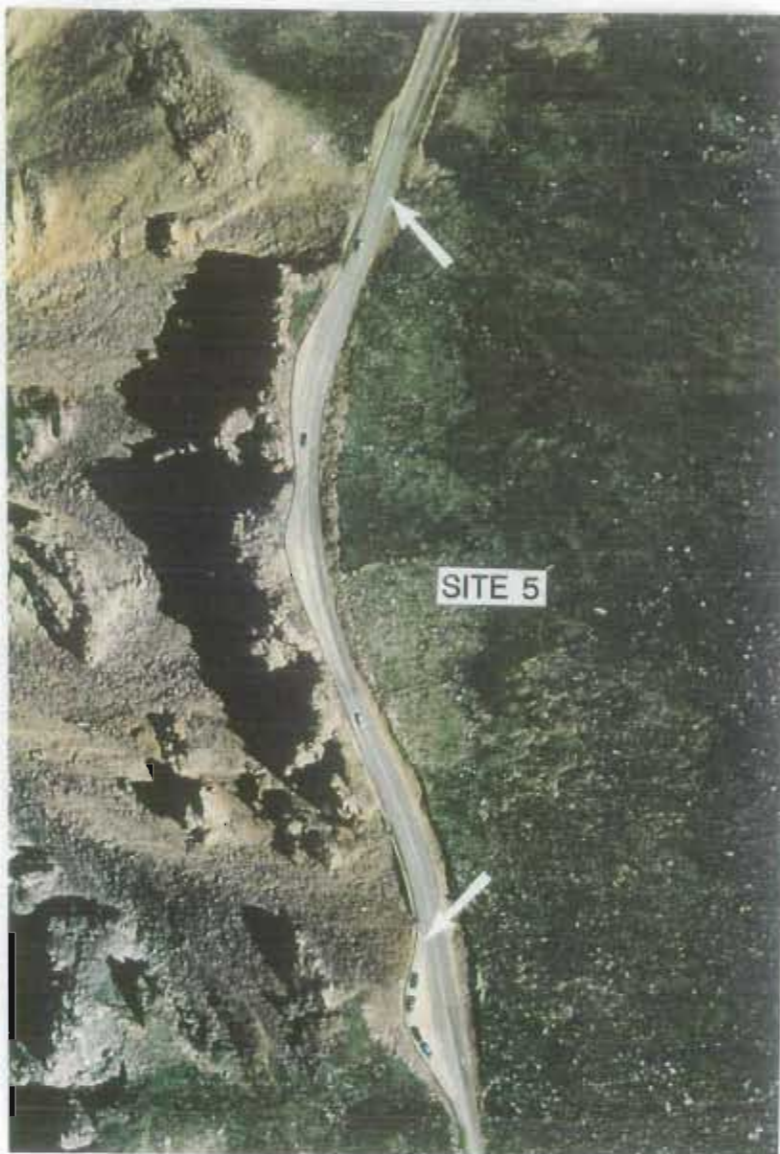
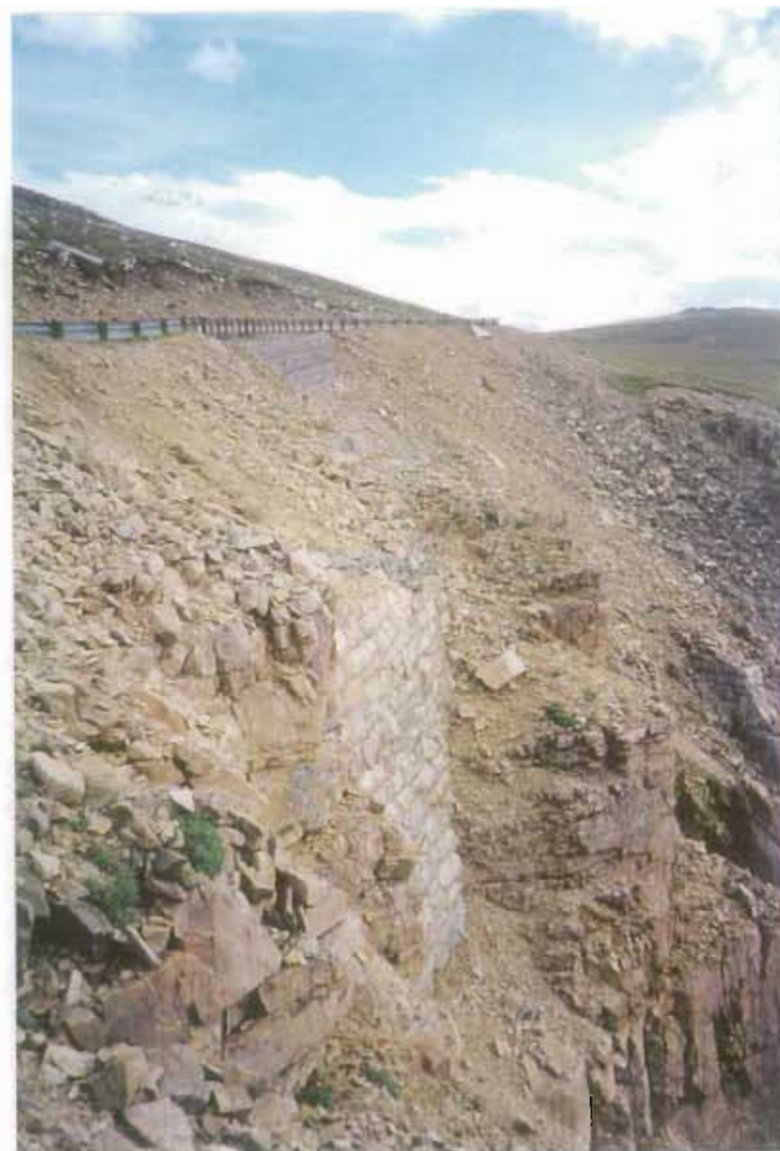
Figure
6

The road traverses the top of high, steep talus slopes. At least two CCC dry stack walls have failed below the road, causing road failure. Two relatively new gabion walls exist near both ends of the site. Mortared stone walls are also in place. The bedrock is closely fractured where it outcrops below the road and appears not well suited for major structure foundations without prior reinforcement. The site is shown on Figure 6.

There is currently a low cut slope above the road, and the natural slope behind the cut is relatively gentle. The natural slope is covered by alpine tundra and the cut slope has very little vegetation.

The geologic hazard is that existing or new walls or structures are undermined by erosion and raveling of the talus slope, or slope failure below the walls. This is judged to be a relatively high hazard, as there is evidence of this happening in the past.

We recommend drilling near the existing walls to evaluate their foundation conditions and drilling 2 or 3 supplementary test holes along the outboard shoulder where it is close to gullies and where MSE walls may be desired. We also recommend the bedrock outcrop be mapped. Mapping should include outcrop location, rock quality, and discontinuity characteristics and orientation.

We understand that for aesthetic and alignment reasons it is desired to widen the road on the outboard shoulder. It is our opinion, based on our site reconnaissance, that this would require construction of large bridge or wall structures with reinforced foundations. Consequently we offer the following preliminary design recommendations:

1. Do not move the existing outboard shoulder outboard more than about 5 feet.
2. Plan to replace gabion walls with keyed in MSE walls, unless investigation shows walls are on strong bedrock foundation.
3. Gain additional width by moving right. Minimize cut if desired by increasing grade elevation.

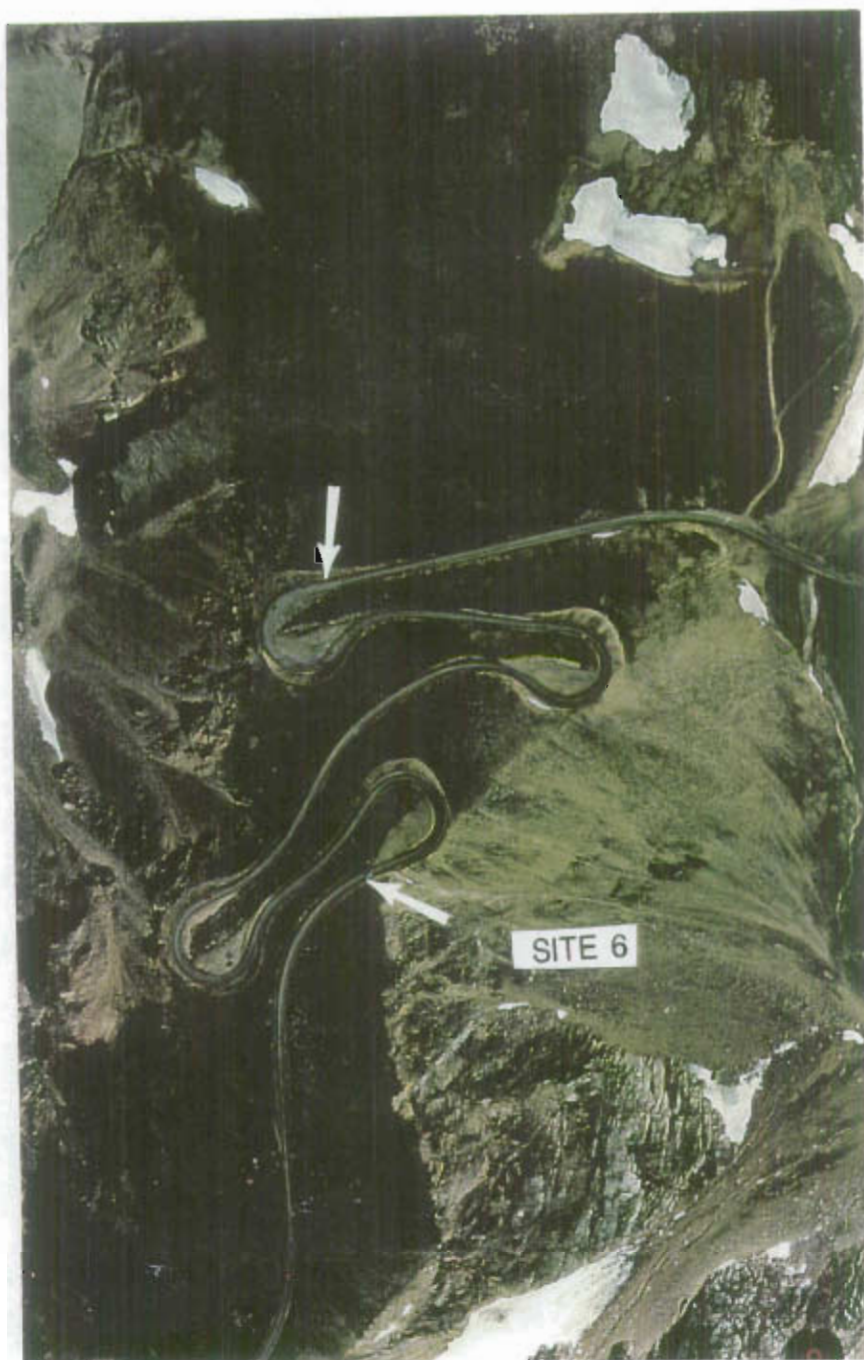
Figure
7

There are four sharp hairpin turns in this area and part of each hairpin turn encroaches on the top of steep east and west facing slopes, as shown on Figure 7. The top of the west facing slope has been stabilized, with varying success, with dry stack and masonry walls.

The geologic hazard is that existing or new walls or structures are undermined by erosion and raveling of the talus slope, or slope failure below the walls. This is judged to be a relatively high hazard, as there is evidence of this happening in the past. There is also the potential for headward erosion of a drainage gully on the upper curve, which is caused by runoff from the road. The stability of this gully could be improved considerably by installation of riprap.

The investigation plan should be developed after a proposed road alignment is selected through the curves. The investigation should focus on foundation conditions for fill or MSE walls, generally at the exit of each curve. Test holes should be drilled at each of these locations. The condition of dry stack and masonry walls, and their foundations should be observed and mapped. If the outboard shoulder is to encroach on any of the existing slope walls, the foundation of these walls should be evaluated by geophysical methods or drilling.

It appears that the road can be widened and an adequate radius maintained by exiting each corner wider on fill sections or, optionally, on MSE walls. This would not require moving the outboard shoulder outboard within the turns and is our preliminary design recommendation for this area.

If the outboard shoulder of the road is to stay where it is, none to relatively minor stabilization of the gullies and dry stack and masonry walls would be recommended. Where necessary, wall foundation stabilization could possibly be accomplished without removing and replacing the walls by installation of micropiles or concrete sills in front of the toe of the walls to control headward erosion. Where stabilization in place is not practical, it may be necessary to replace the walls with walls buried to greater depth or founded on bedrock. Walls that are in poor condition should be replaced.

If the shoulder is moved outboard through the turns, large walls will likely be required. In this event, the existing dry stack and masonry walls should be replaced with new MSE walls founded on bedrock. Bedrock appears to be within a few feet of the surface, and closely fractured, which should facilitate excavation for a wall foundation, if required.

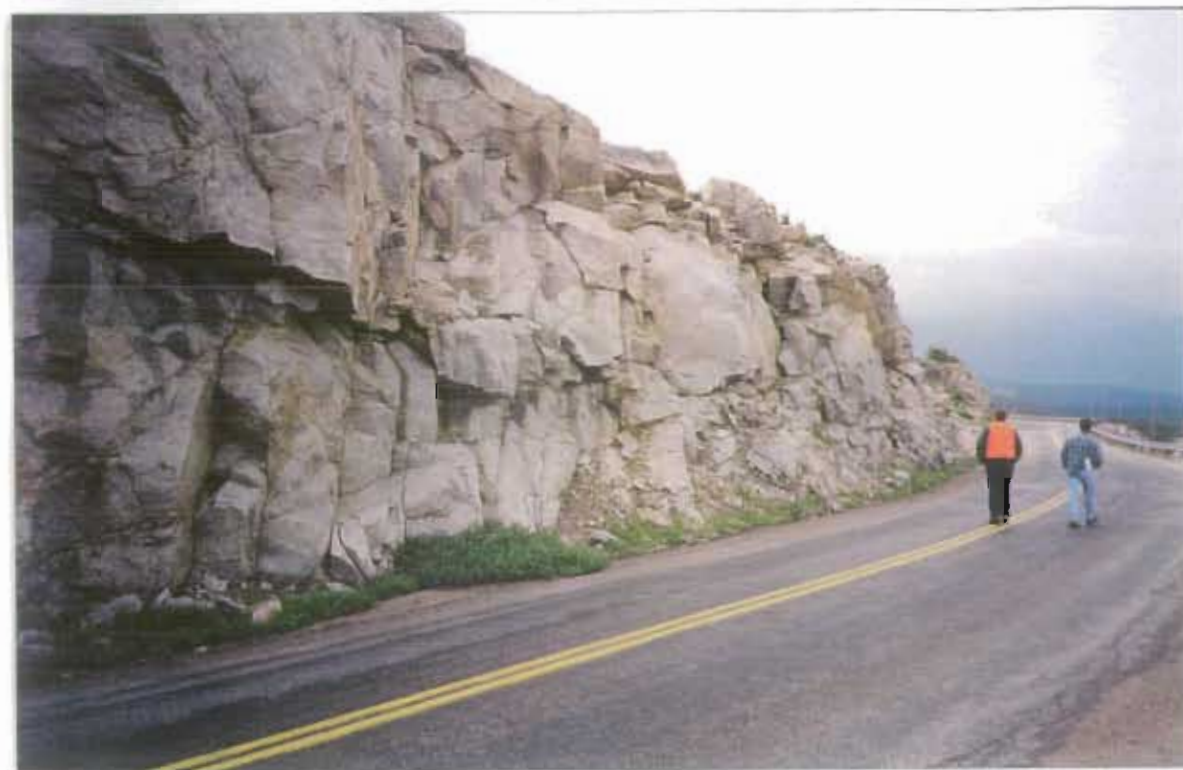
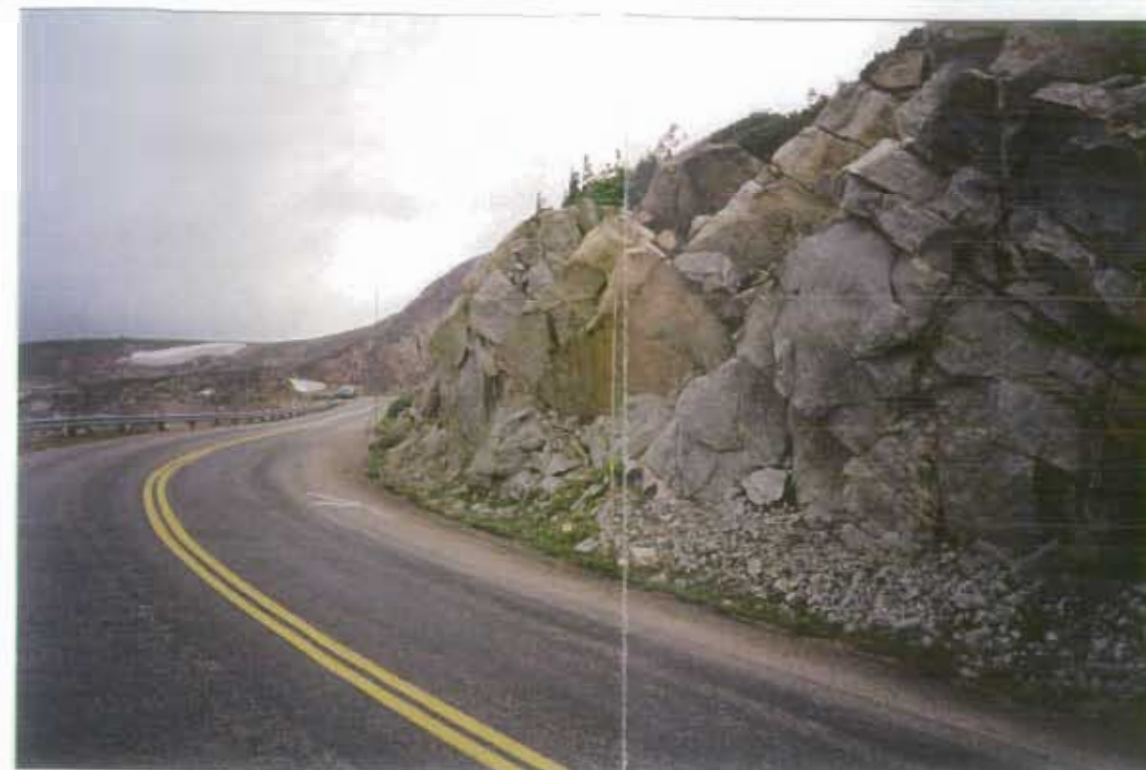
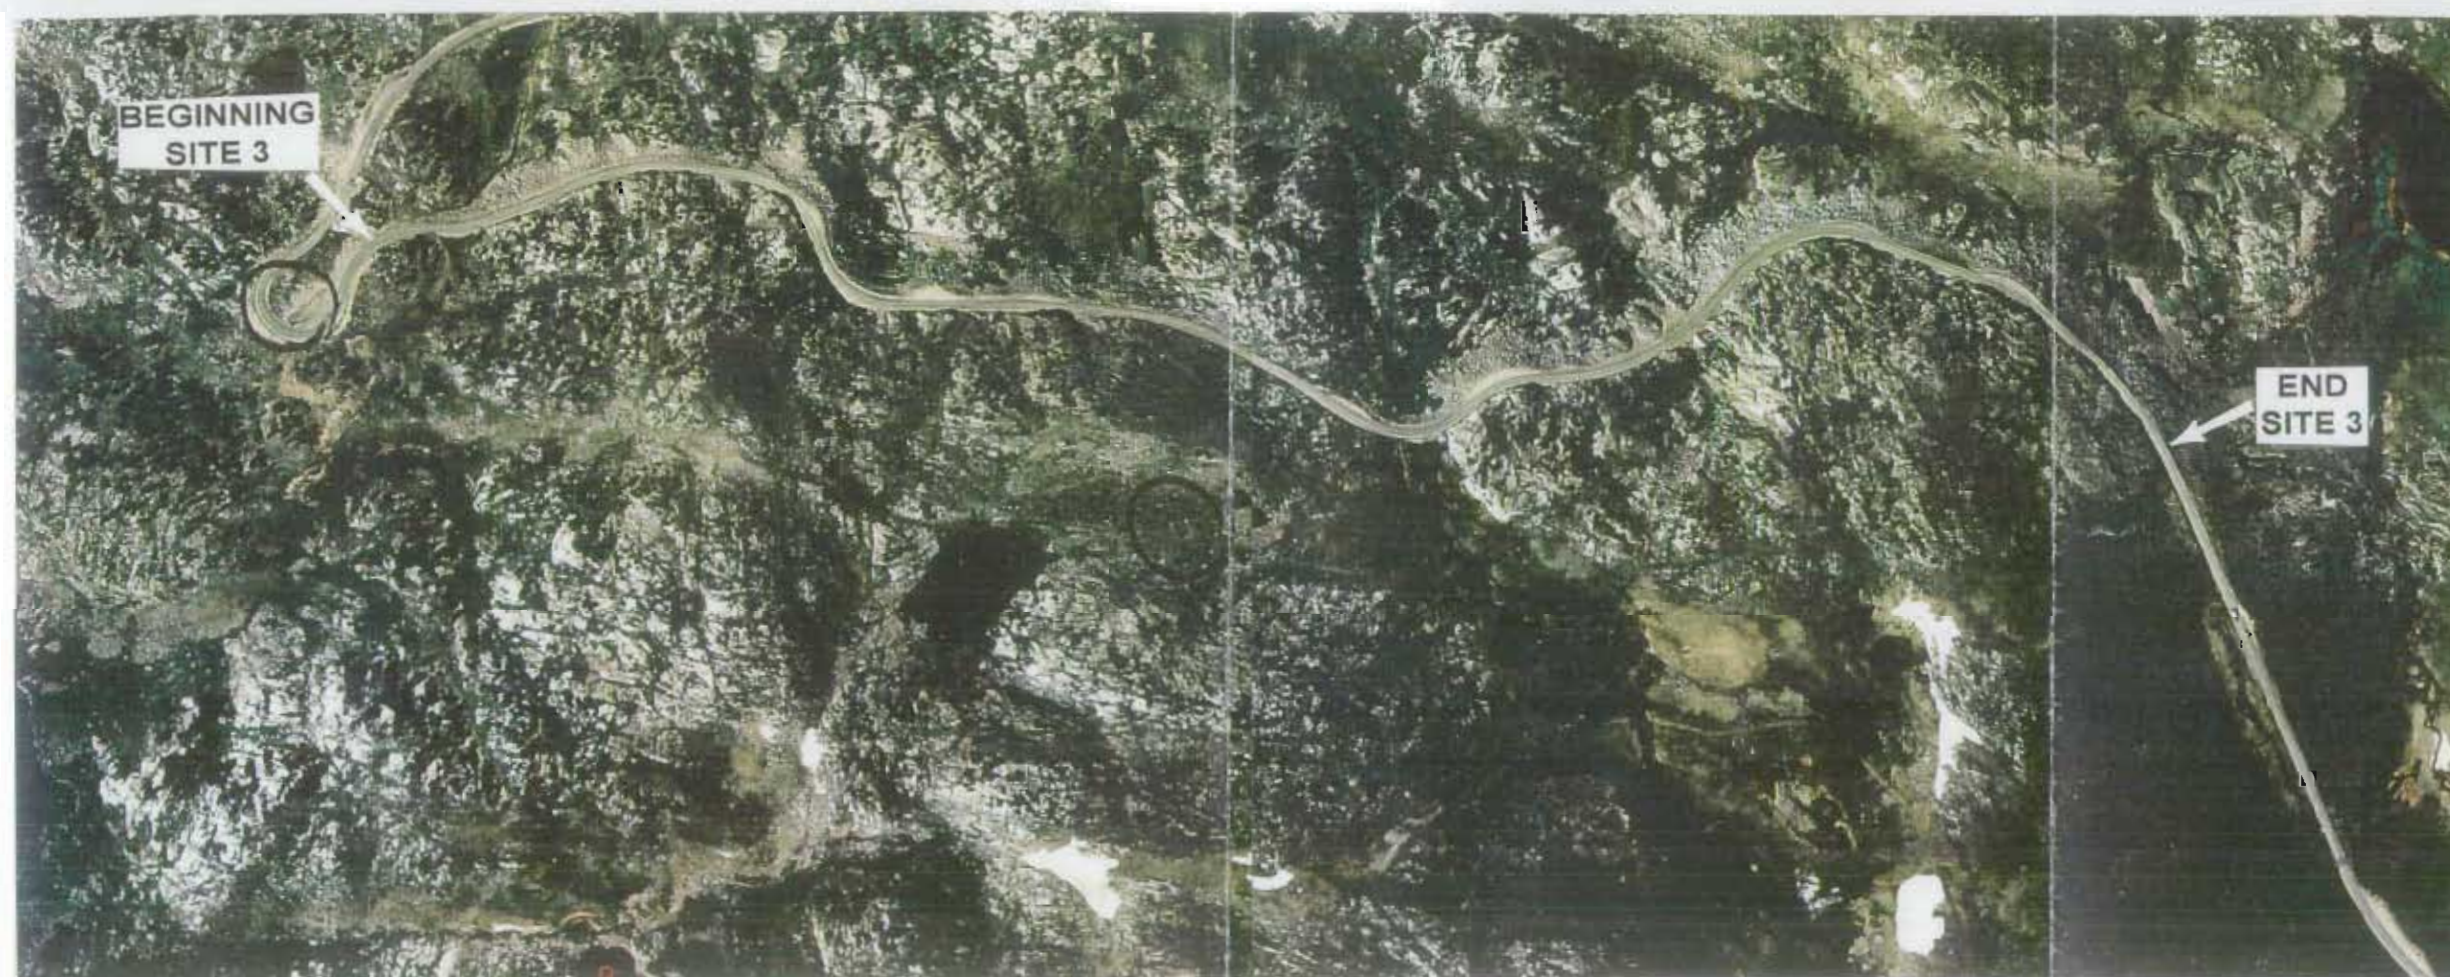
Figure
 4

This relatively long stretch of road is above timberline and traverses a slope which gently slopes to the west. Granitic bedrock, which appears to have been scoured by glaciers, outcrops above and below the road (Figure 4). The road has several cut and fill sections of low to moderate height, and several small radius curves within the bedrock outcrop.

Most of the rock is fairly massive granite, with typical joint spacing on the order of 0.5 to 3.0 m. Prominent joint sets include a low-angle set, which generally dips into the cut and two near vertical sets which form part of the existing rock face.

Rock slope stability and rockfall are the potential geologic hazards at this site if the road is widened and straightened as planned. This hazard will likely be low because of the generally good rock quality and favorable joint orientations.

The investigation should include surface mapping of the rock outcrop to identify joints and joint spacing for design of rock cut slopes. Test holes may also be desired through existing fills to evaluate foundation conditions. Standard investigation procedures should suffice.

Rock slopes can probably be designed so as not to require reinforcement, but care will need to be taken to provide a natural looking rock face. A blasting plan submittal should be required prior to construction and it should be reviewed by a qualified engineer or geologist. It will likely be necessary to create some large, fresh fracture faces, and staining with ironite or equivalent should be considered. Because of the variability in the road bearing and possible variability in joint orientations, the desired rock slope design may vary throughout this site.

Much of the material generated from the cut may be too large to be good highway fill material without further splitting or crushing. By comparison, the rock at Station 41+600 to 42+000 is more fractured and weathered, and a cut through this area would probably generate material that could be used more readily in road fill.
